DEPARTMENT OF TRANSPORTATION**DIVISION OF ENGINEERING SERVICES**

Contract #: 04-0120F4Cty: SF/ALA Rte: 80 PM: 13.2/13.9File #: 69.28**WELDING INSPECTION REPORT****Resident Engineer:** Pursell, Gary**Address:** 333 Burma Road**City:** Oakland, CA 94607**Report No:** WIR-004755**Date Inspected:** 06-Nov-2008**Project Name:** SAS Superstructure**OSM Arrival Time:** 1400**Prime Contractor:** American Bridge/Fluor Enterprises, a JV**OSM Departure Time:** 2300**Contractor:** Zhenhua Port Machinery Company, Ltd (ZPMC), Changxing Island **Location:** Shanghai China**CWI Name:** Sun Bo**CWI Present:** Yes No**Inspected CWI report:** Yes No N/A**Rod Oven in Use:** Yes No N/A**Electrode to specification:** Yes No N/A**Weld Procedures Followed:** Yes No N/A**Qualified Welders:** Yes No N/A**Verified Joint Fit-up:** Yes No N/A**Approved Drawings:** Yes No N/A**Approved WPS:** Yes No N/A**Delayed / Cancelled:** Yes No N/A**Bridge No:** 34-0006**Component:** Tower/ OBG**Summary of Items Observed:**

WELDING INSPECTION REPORT

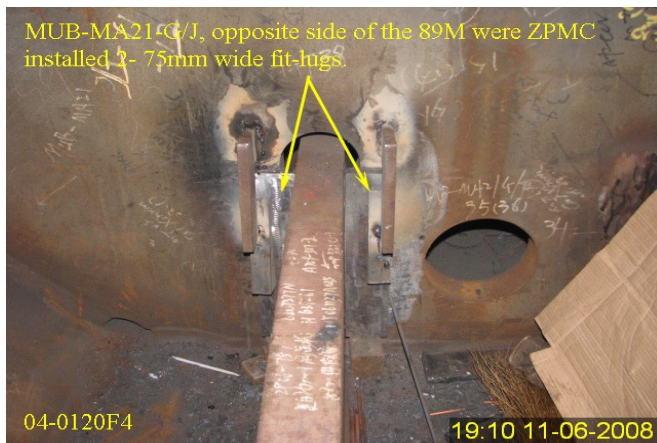
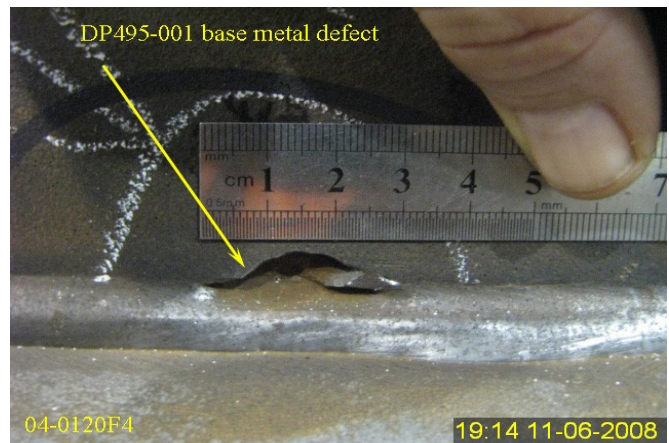
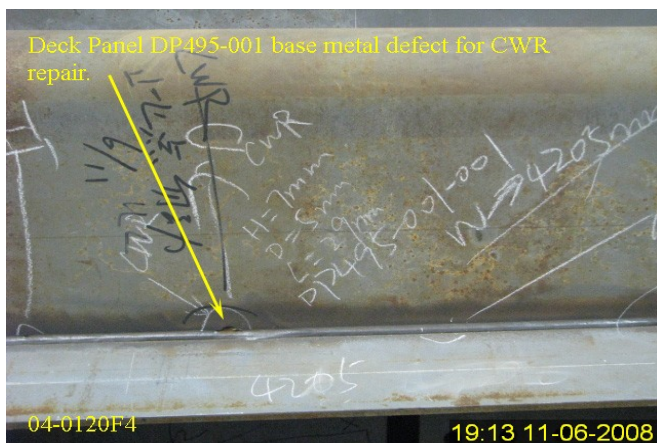
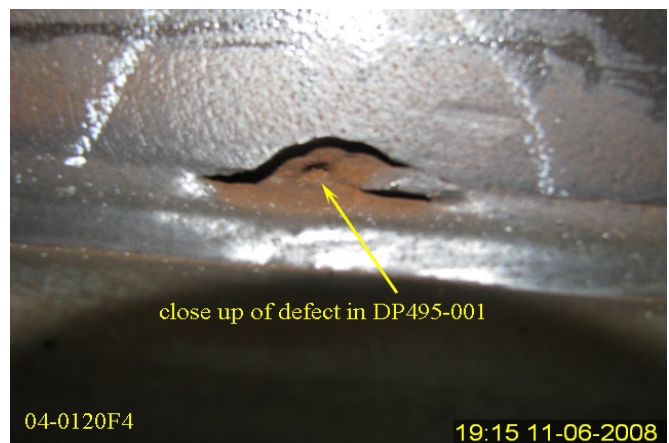
Caltrans QA Inspector observed that ZPMC did not perform the weld trial on this shift today due to inclement weather conditions. It was noted that on a previous shift ZPMC had fit-up 2 fit lug plates on the MUB-MA21-G/J side of the 89M mock-up the plates were located on the left hand side of the mock up with the size of the lug plates were 75X370X30mm. See digital photos below for locations of fit lugs.
